# Paisley News

Issue 12 22/07/11 **J . E . PAISLEY & C O L T D**

## ***Common Rail engine failures***

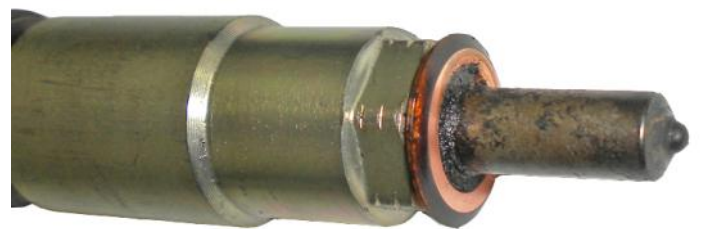
**Normal seal condition, very little carbon build up**

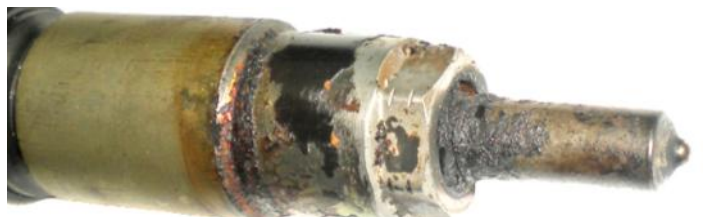
The first signs of injector seat failure, is white smoke and an engine misfire at first startup cold. When these symptoms become apparent the injectors should be removed and new seals fitted.

**Start of seal failure, note start of carbon build up on nozzle**

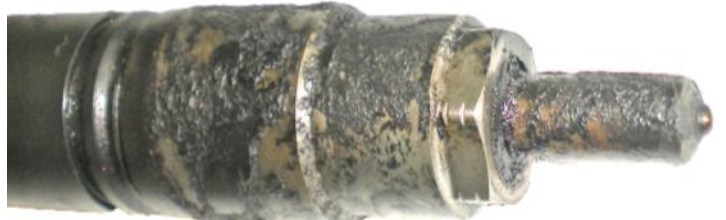
There have been an increasing number of engine failures to common rail engines directly contributable to the injector seating washer failing, when the injectors are located under the rocker cover.

When the seating washer fails, it allows carbon to form in the lubricating oil. (see the illustrations) this carbon blocks the oil pick up restricting oil flow to major engine components, (bearings etc)

**Total seal failure, heavy carbon formation on nozzle and injector body.**
