Paisley News

January 2013

J . E . PAISLEY & CO LTD

Common Rail Suction control valve and gear pump
failures

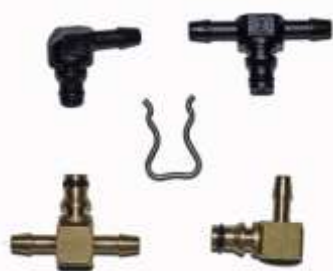
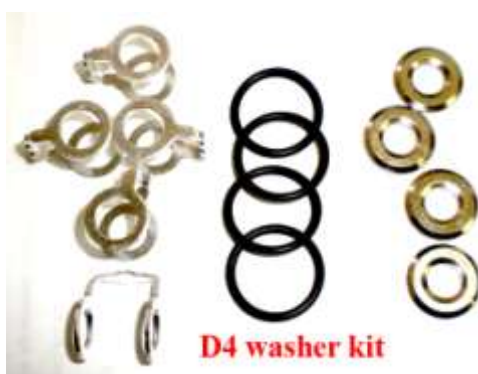
Return line fittings for
common rail injectors

D4 washer kit

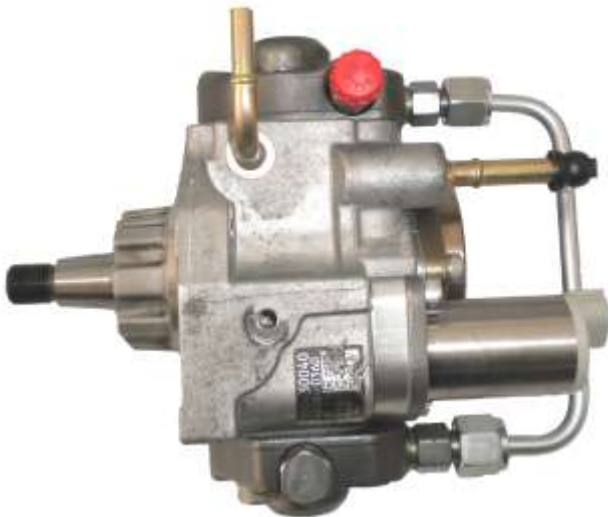
Scored SCV piston

Common problems related to the SCV on the vehicle are stalling, hard starting and hunting, sometimes a low rail pressure code will be logged. Typically the SCV piston will be heavily tarnished or scored from metal particles causing the valve to become erratic in operation.

Scoring of the suction control valve is often caused by fine particles of metal being dislodged from the pre-supply pump lobes. These metal particles can also cause pre-mature injector failure, something to keep in mind when replacing injectors on high mileage vehicles as it may well be worth considering having the high pressure pump removed and the gear pump lobes checked for wear. It is not possible to remove and replace the gear pump on the vehicle due to alignment issues. Failure to correctly align the gear pump rotors and cover will result in total failure of the high pressure pump assembly.
